# **Aviation Occurrence Report Volume II**

ASC-AOR-05-02-001

**IN-FLIGHT BREAKUP OVER THE TAIWAN STRAIT**

**CHINA AIRLINES FLIGHT CI611**

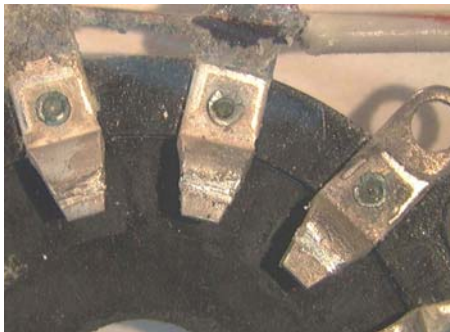
Figure 15: **MODE SELECT** Rotary Switch, Stationary contacts, deck 3, #1-2-3 (left to right).

- Contacts of rotary switch (S1), deck 3, #1-2-3, Wear marks on contacts appear to be normal.

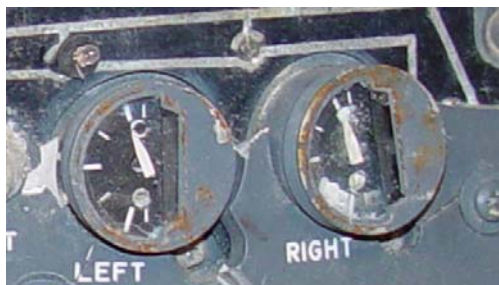
Figure 16: Panel, **OUTFLOW VALVES** Indicators.

- Internal surface of glass face: small surface anomaly observed as viewed from exterior.
- Case removed to inspect glass from inside. What appeared to be an anomaly on the inner side of glass was actually a debris deposit.
- No impact indications from needle impact were noted.

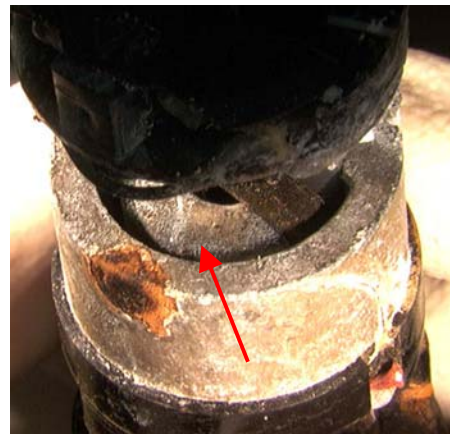
**Figure 17: LEFT, OUTFLOW VALVES**  
Position Indicator witness mark

**Figure 18: LEFT, OUTFLOW VALVES**  
Position Indicator showing witness mark after moving armature.

- Moving armature/needle, mounting tab corresponds to a witness mark on underlying base. This position corresponds to needle positioned at approximately 25% open. The armature was moved from its location in Figure 17 to display the “witness” pattern underneath the movable armature, shown in Figure 18.

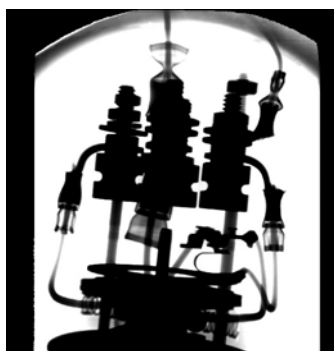
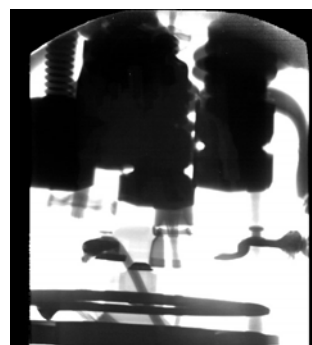
**Figures 29A, 29B, 29C:** X-rays of Pack Valve Switch #3

- Corrosion on all metallic parts
- Severe cracking of the switch body.
- No continuity could be attained.
- All external wiring appears intact.
- X-ray shows that the valve-closed electrical contacts are not aligned with each other. Misalignment approximately 10 degrees. The switch knob was not in the full closed position.

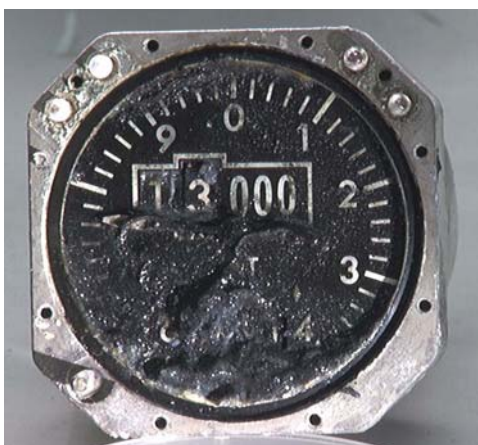
**Figure 43:** Cabin Altimeter Indicator, glass bezel removed

- Heavy coating of unknown sedimentary type debris on face of indicator (unknown black glutinous contaminant).
- After cleaning off debris, altimeter indicator reading confirmed to be 13,765 +/- 5.
- Microscopic examination of inner side of bezel shows no sign of impact damage.

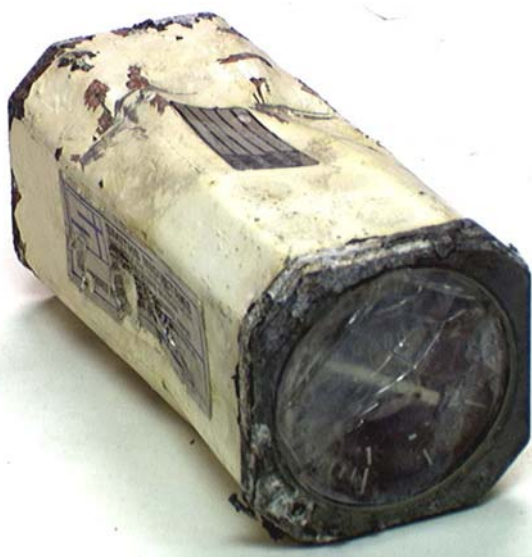
**Figure 48:** Cabin Vertical Speed Indicator

- Glass is broken.
- Numerous dents are on case.
- Needle is frozen at 500 FPM climb.

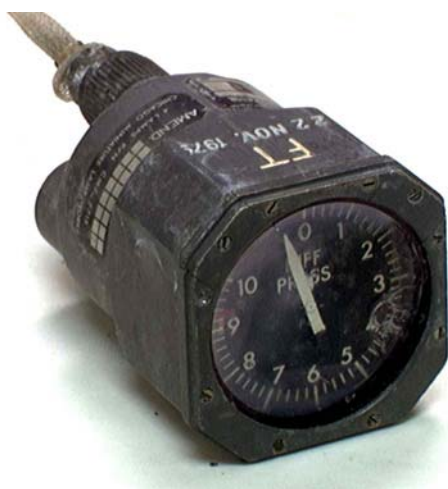
**Figure 50:** Cabin **DIFF PRESS** Indicator

- Water stains inside glass face.
- Needle is indicating below zero.

- Removal of the bezel did not reveal any abnormal markings on inside of glass.
- Dial indicated less than zero (at approximately 0.6 - 0.8 psi).
- Casing was removed. Cabin pressure line was cut to remove indicator from case. When pressure line was cut, the indicator dial returned to zero.
- No apparent damage was visible to internal parts.
- Minimal corrosion was present on internal surfaces.
- Red scale mark on face at approximately 9.25 – 9.3 (mechanism is physically limited at that point).

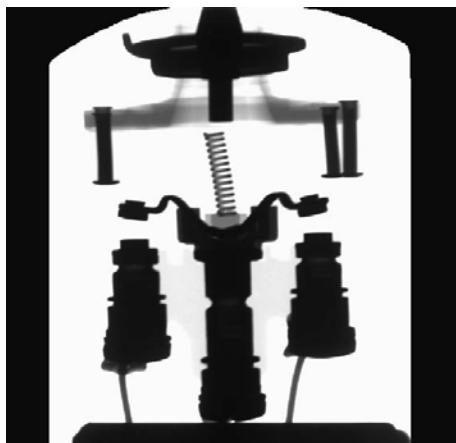
**PASSENGER OXYGEN** control switch of Module M183 was found to be in the **NORM** position as received. Continuity tests indicated that the switch functioned properly in the **ON**, **NORM** and **RESET** positions. See Figures 54 through 58.

Figure 54: X-ray of switch

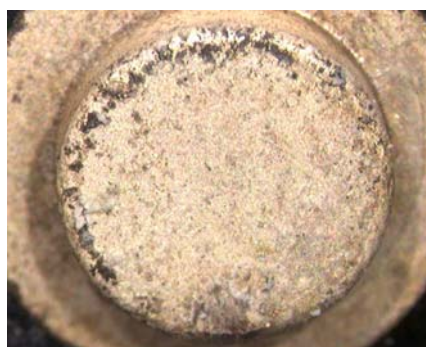
Figure 58: Stationary contact of oxygen control switch ("RESET" position).

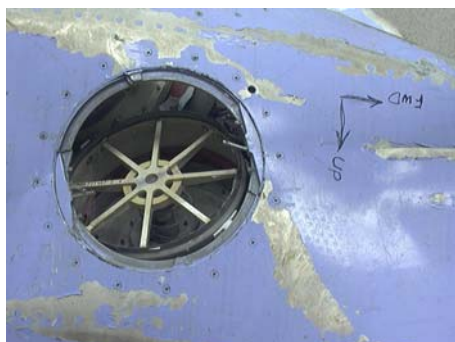
**Figure 81:** Upper Pressure Relief Valve, showing orientation, note that blowout doors are missing.

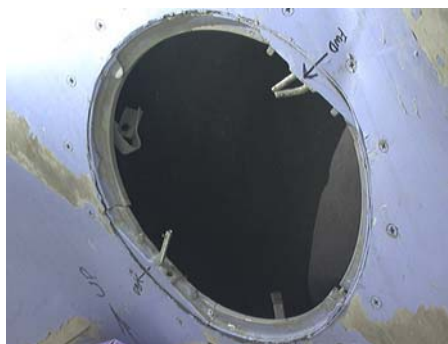
**Figure 95:** Upper Pressure Relief Valve, same as # 94, another view.

- Performed **measurement** of pin angles using a flat reference plane (outer skin of aircraft); using two imaginary reference lines running between the centerlines of the pin mounting holes (upper fwd to upper aft) & (lower fwd to lower aft). All angular measurements were based from these two imaginary lines. (See: diagram. Upper Valve, flapper doors' pins, orientation, Figure 96).
- Results of measurements (approximation):  
Upper aft pin = 13°; Upper fwd pin = 161°; Lower aft pin = 53°

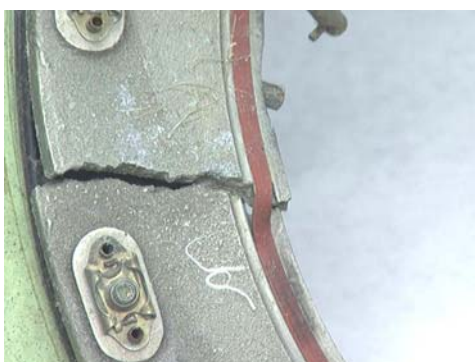
**Figure 97:** Non-metallic washer (gate seal) - continuous ring.

- Slight impression of knife-edge on seal.

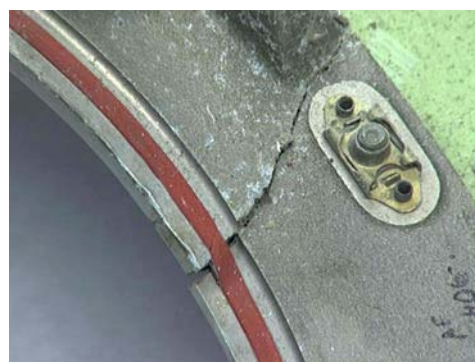
**Figure 98:** One slight cut adjacent to housing fracture.

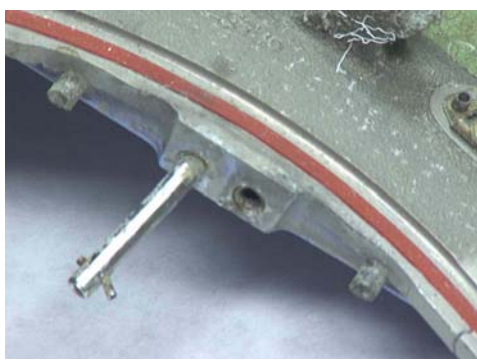
**Figure 101:** Forward stops & hinge pin, (looking from inside to outside).  
 • Forward/lower hinge pin is missing.

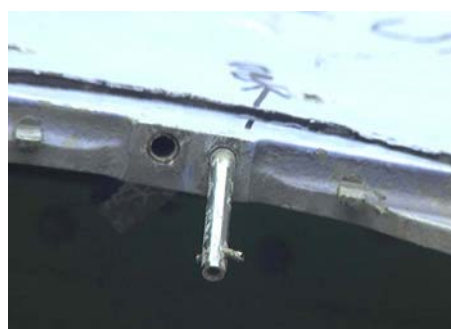
**Figure 104:** Forward/upper hinge pin, physically rotated by hand to bend inboard.

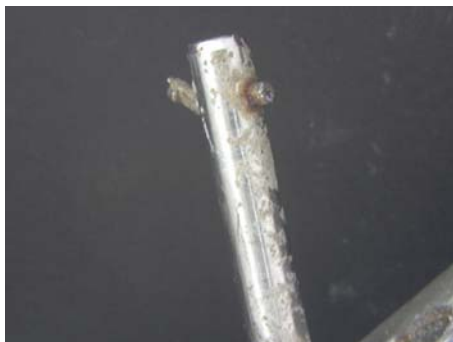
**Figure 105:** Detail of forward/upper hinge pin end.

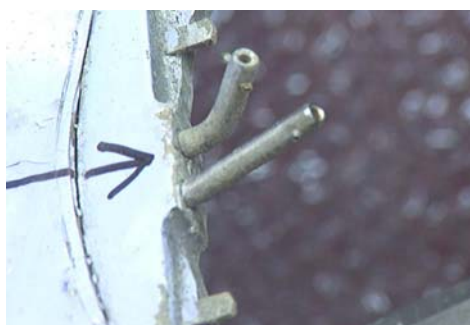
**Figure 107:** Aft hinge & stop pins, (looking from outside to inside)

- Aft/upper hinge pin (lower pin in photo) is difficult to rotate.
- Aft/lower hinge pin (upper pin in photo) rotates.

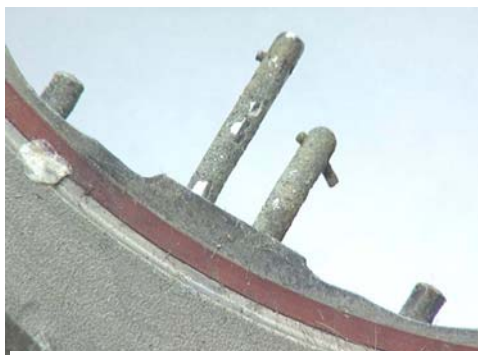
**Figure 108:** Close-up of aft stop & hinge pins (looking from inside out).

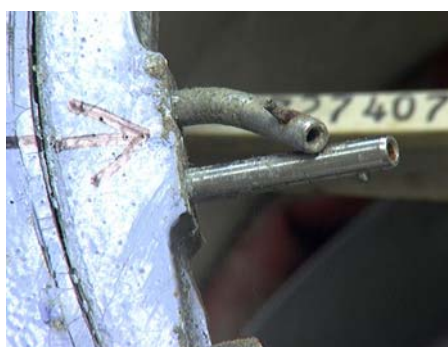
**Figure 109:** Close-up of aft hinge pins (looking from outside to inside).

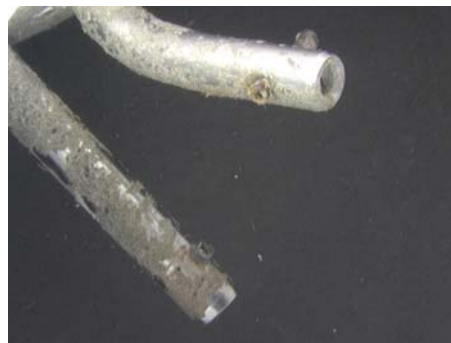
Figure 111: Aft hinge pins, upper & lower. Both pins rotated to "closed door" position.

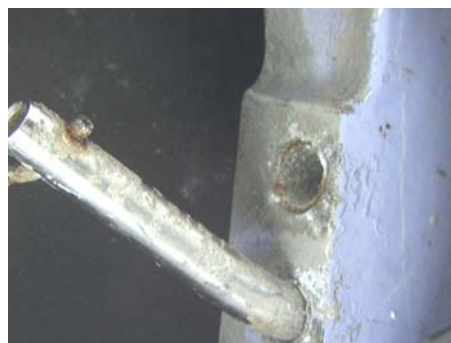
Figure 114: Detail of forward/lower hinge pin bushing in hole.

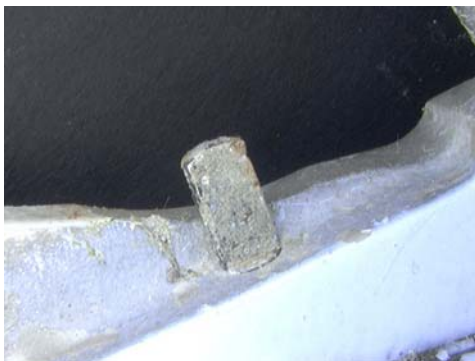
[Figure 119](#): Overview of forward/upper stop pin, as viewed from outside.

- Pin is relatively straight, paint missing.

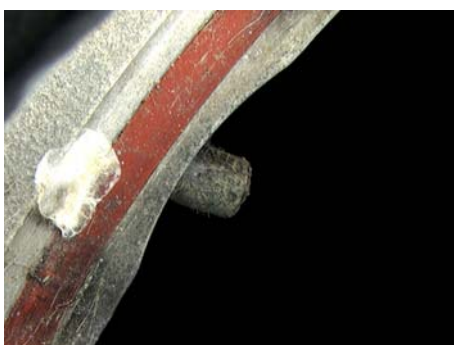
[Figure 122](#): Overview of aft/upper stop pin, as viewed from inside.

- Pin is relatively straight.

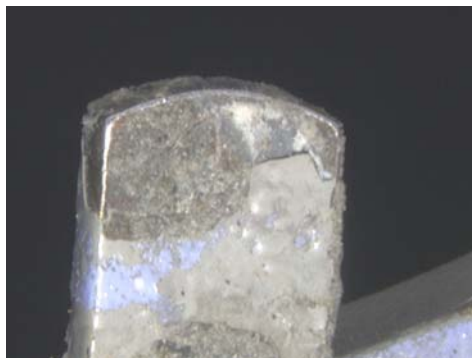
**Figure 132:** Forward/lower stop pin, close-up of figure #131.

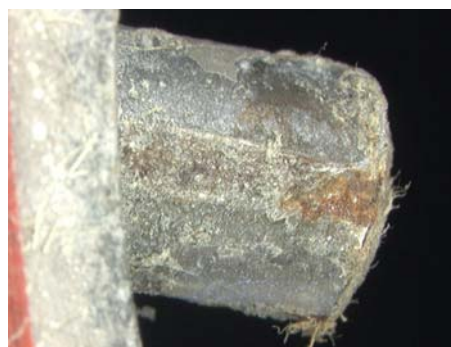
**Figure 134:** Aft/lower stop pin; close up of figure #133.

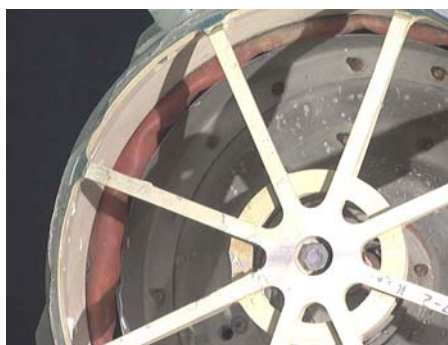
**Figure 147:** Diaphragm, apparently intact portion.

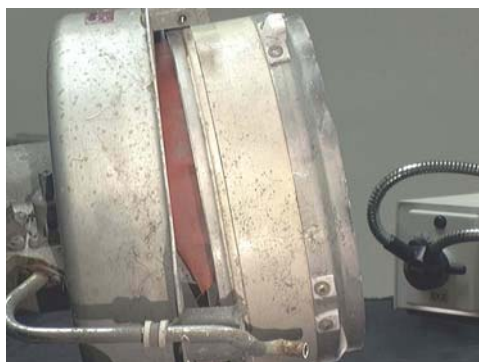
**Figure 149:** Offset angle between valve housing and gate.

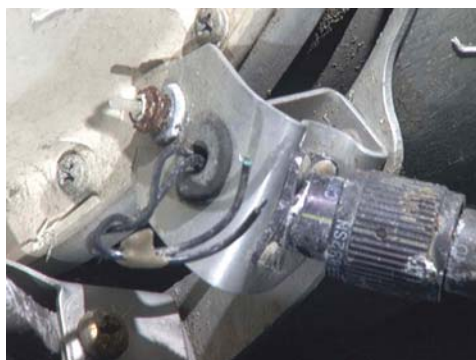
**Figure 151:** Switch mounting bracket, gate is against bracket.

- The switch actuator is intact but the basic switch is missing.
- The (electrical connector and plug) mating is intact.

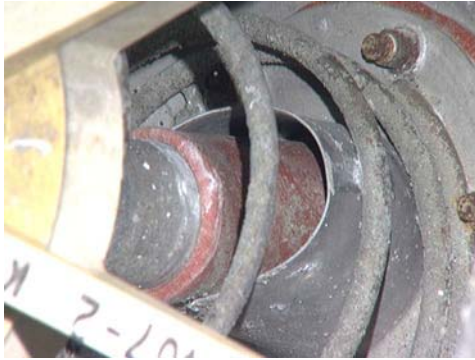
**Figure 153:** Center diaphragm & return spring.

- Diaphragm is intact and spring is unseated from valve cover.

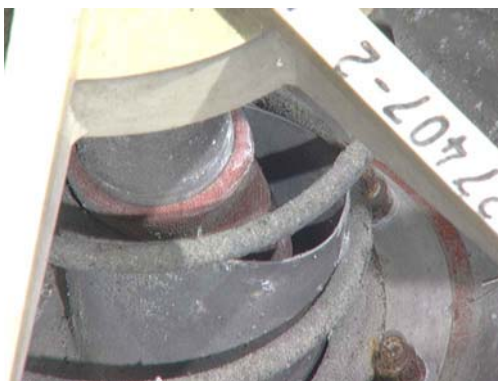
**Figure 154:** Center diaphragm guide, HS P/N 727411-1, showing distortion of guide itself.

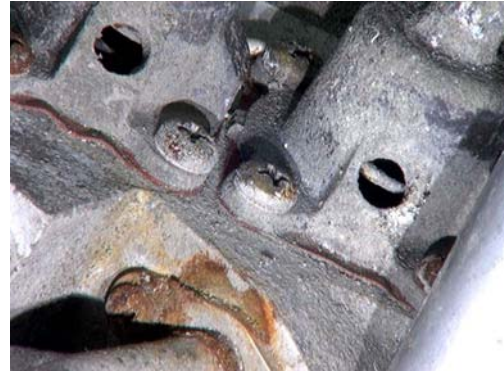
**Figure 158:** Cabin pressure sense ports on sensor adjustment springs.

- Holes look clear.
- Corrosion on tube retainer plate (HS P/N 727417-2).

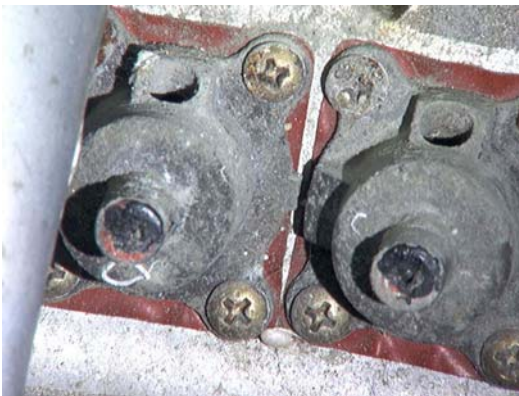
**Figure 159:** Control adjustment screws.

- Tamper proof seals are in place.

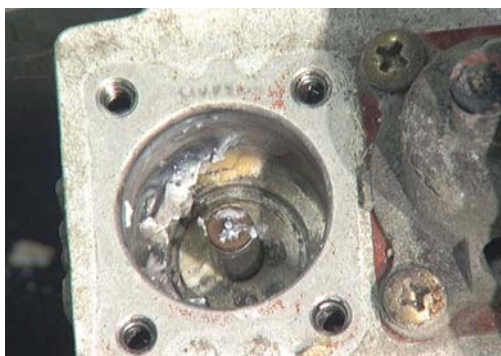
[Figure 165](#): Remote ambient sensor housing bore.

- Salt & moisture present.
- Poppet is frozen.

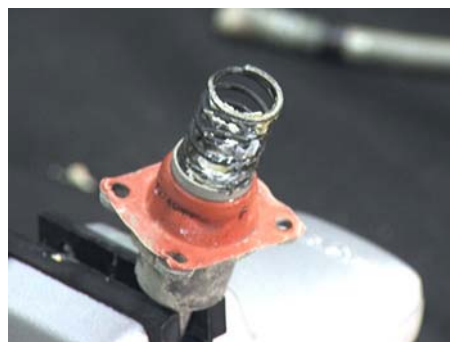
[Figure 166](#): Diaphragm appears to be intact.

- Salt deposits on spring.
- Heavy corrosion on spring seat (one-third).

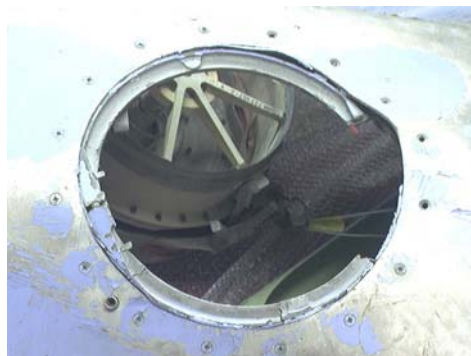
**Figure 179:** Exterior opening for Lower Pressure Relief Valve (valve still inside).

- External view shows the heads of 5 attachments screws to the skin, are missing and about 25% of mounting flange is missing.

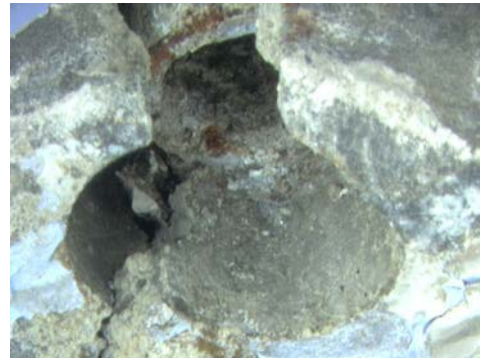
**Figure 187:** Forward/upper hinge pin, close-up of partial bushing.

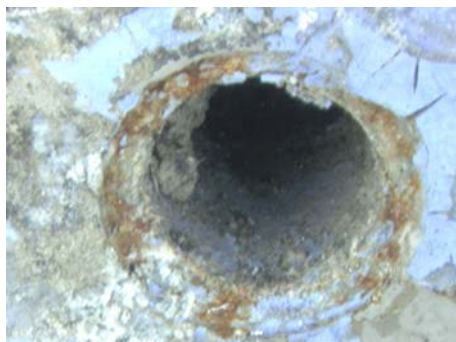
Figure 188: Forward/upper hinge pin, close-up view of partial bushing in hole.

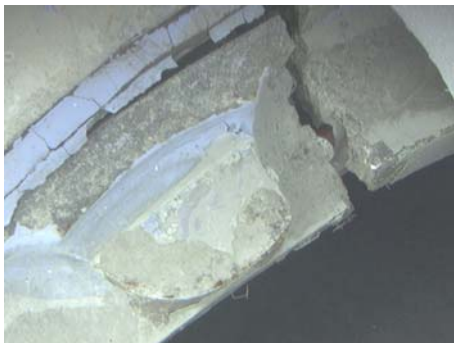
**Figure 200:** Lower stop pad, with adjacent crack on housing.

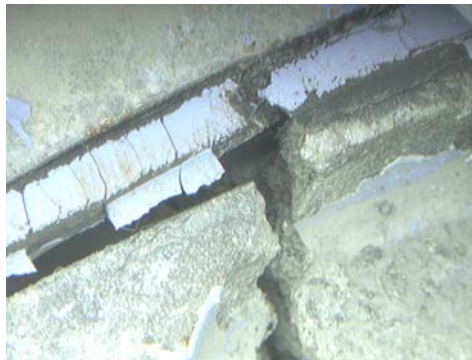
**Figure 201:** Detail of lower stop pad.

- It is broken away from housing (housing cracked).

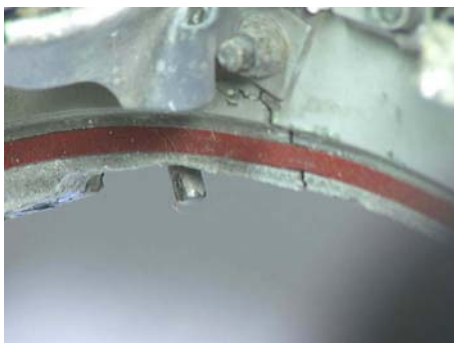
**Figure 204:** Exterior door open, forward/lower stop pin, HS P/N 730539-1, as viewed from inside.

- Appears to be normal and not bent relative to valve housing.
- Note: aft upper & lower pins are missing along with a portion of valve housing that they are normally installed in.

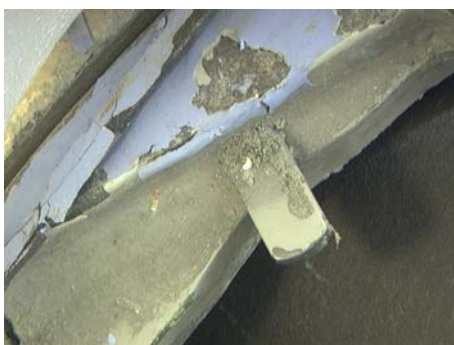
**Figure 207:** Forward/lower, stop pin as viewed form outside.

- Pin is relatively straight.
- Paint is chipped.

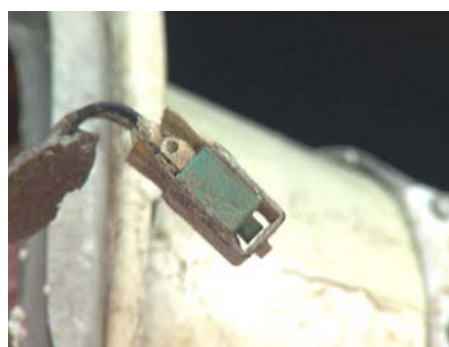
**Figure 212:** Switch (side view): actuator is missing from switch housing.

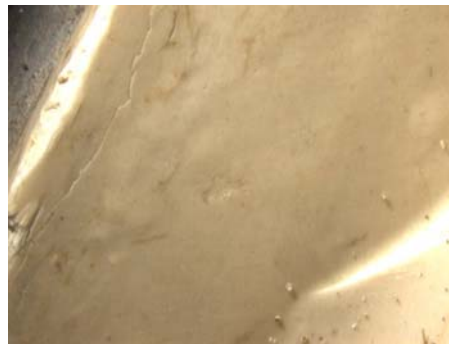
**Figure 214:** Lower Pressure Relief Valve; detail of valve gate, switch contact area.

Continuity verified in the normally relaxed condition, per normal installation.

When plunger was depressed, switch changed state (of circuit).

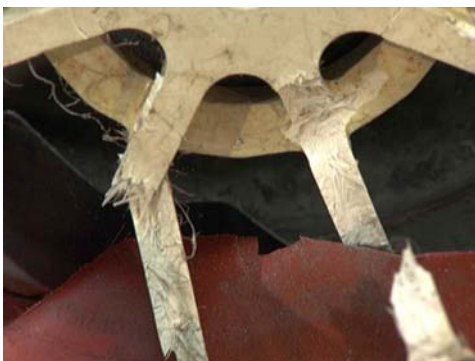
Figure 216: Gate webs, detailed view of broken web members.

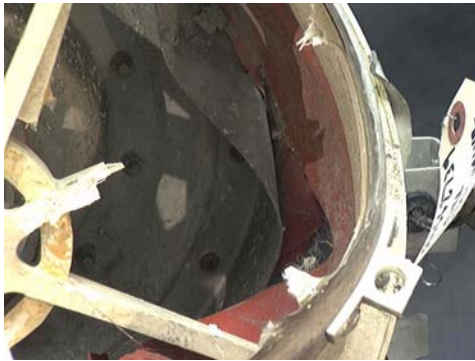
[Figure 218](#): Web damage.

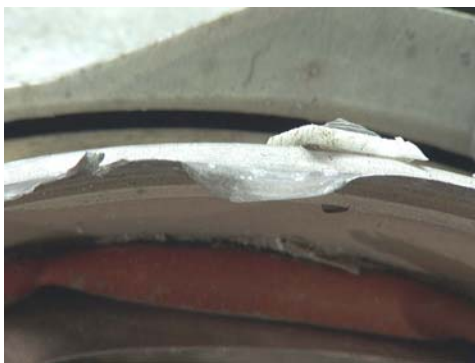
[222](#): Knife-edge damage.

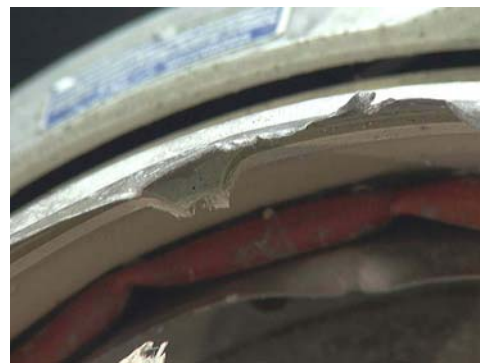
[Figure 223](#): Knife-edge damage.

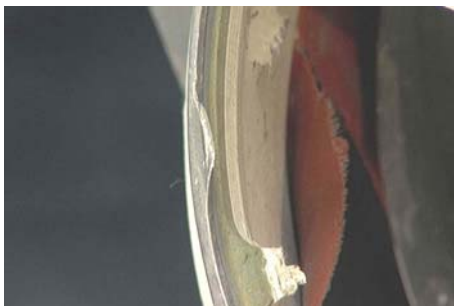
Figure 224: Knife-edge damage.

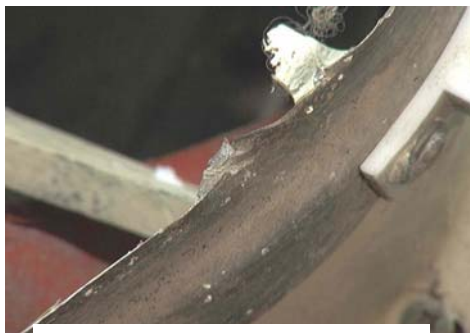
Figure 225: Knife-edge damage.

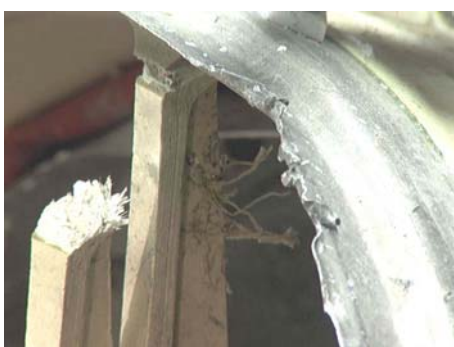
Figure 226: Knife-edge damage.

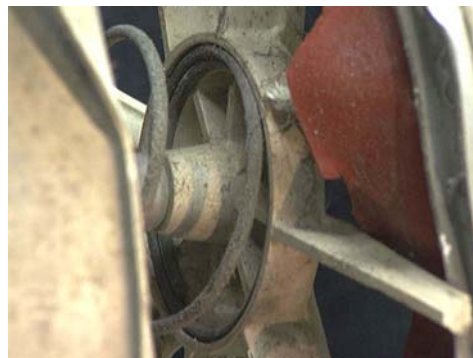
**Figure 237:** Gate return spring is seated in the gate. The end coil appears to be inside the last active coil.

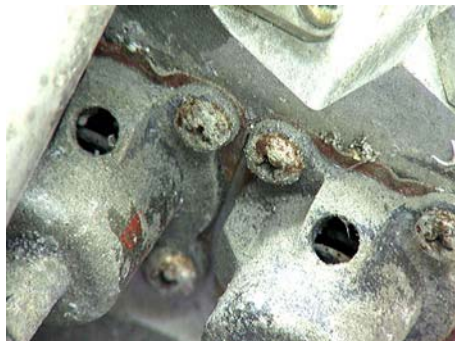
Figure 241: Cabin pressure sense ports.

- Ports appear to be un-plugged.
- Some accumulation deposits.
- Springs appear to be in place.

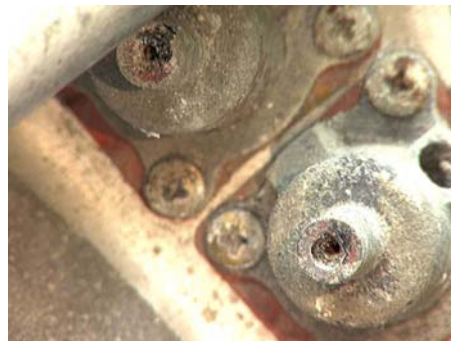
Figure 242: Control adjustment screws, both appear to be intact.

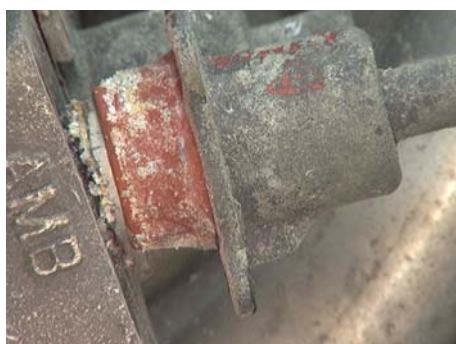
**Figure 249:** Remote ambient sensor, cover and diaphragm partially removed.

- Heavy salt deposits on spring, piston and diaphragm.

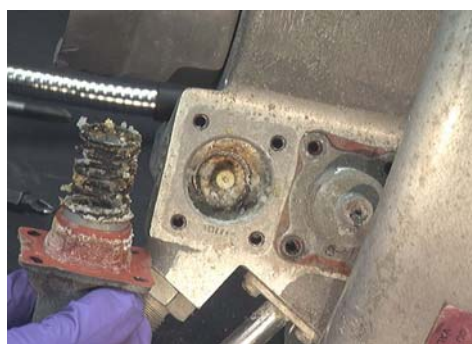
**Figure 250:** Showing remote ambient sensor removed.

- Heavy salt deposits on spring & housing bore.
- Diaphragm appears to be intact, poppet moves freely.

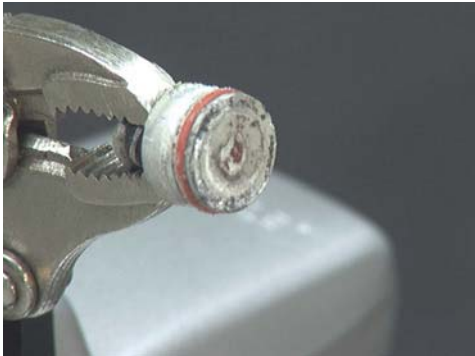
**Figure 253:** Plug HS P/N 719280-1 and seal, seal looks normal and uncut.

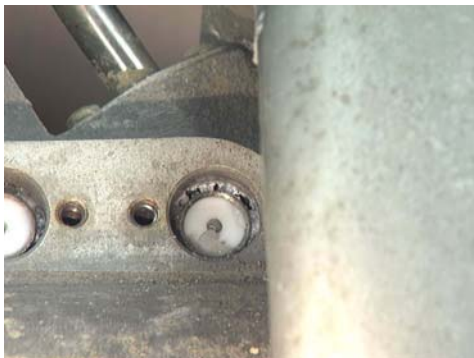
**Figure 256:** Opposite end of integral sensor poppet and guide; heavy salt deposits.

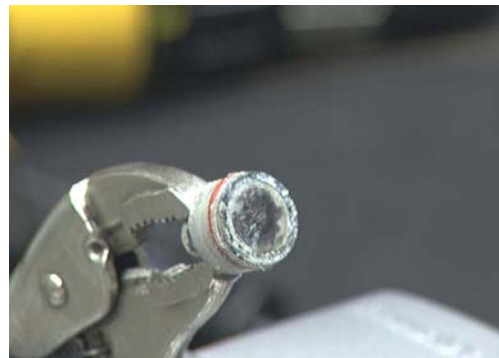
**Figure 257:** Plug for integral sensor, seal looks normal and uncut.

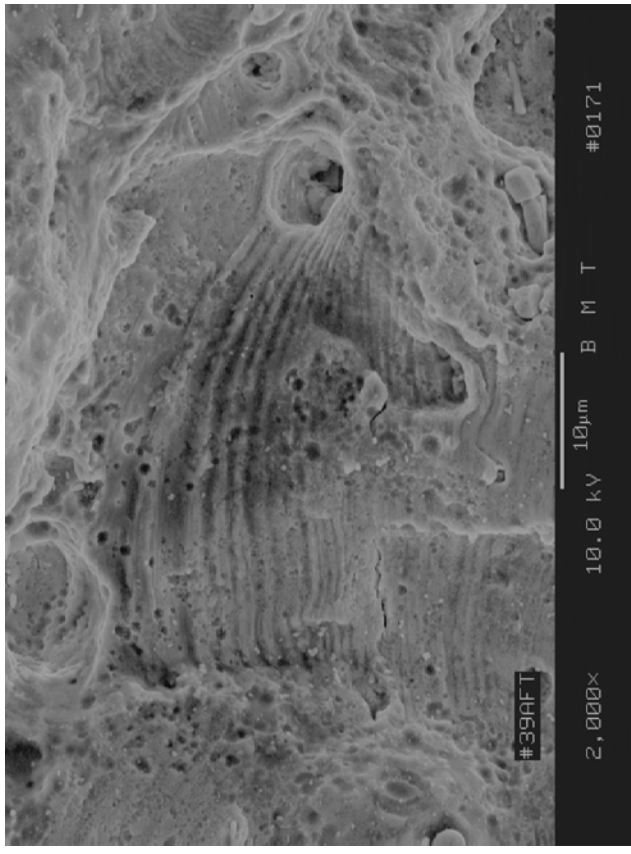
Figure 14, scanning electron microscope photographs showing fatigue striations near the end of the flat profile fracture surface aft of Hole 39. Just beyond these regions, the fracture surface was dominated by a dimpled morphology, indicative of the fracture mechanism of micro-void coalescence, or ductile separation. Severe pitting due to corrosion can also be seen.

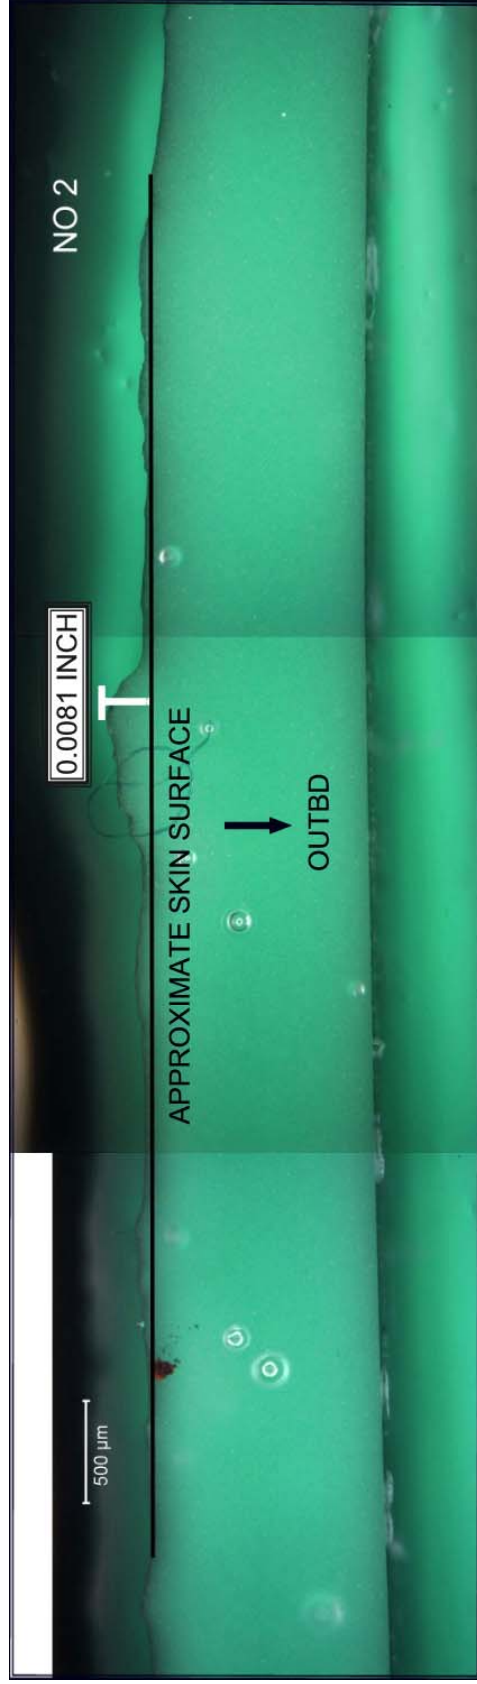
A surface replication medium was applied at five locations on the skin repair faying surface as shown in Figure 38 to examine scratch geometry and depth. The locations were chosen to display surface features typical to areas exhibiting major scratching. This medium creates a "positive" of the surface it is applied to, enabling direct feature measurement from the replica. The maximum scratch depth measured with this technique was 0.0096 inch. Composite photographs exhibiting scratch profiles at locations noted above are shown in Figures 39 and 40.

FIGURE 39: SCRATCH PROFILE COMPOSITE PHOTOGRAPHS – The replication medium creates a “positive” of the skin scratches. Scratch features of replica locations 1 and 2 are shown above.

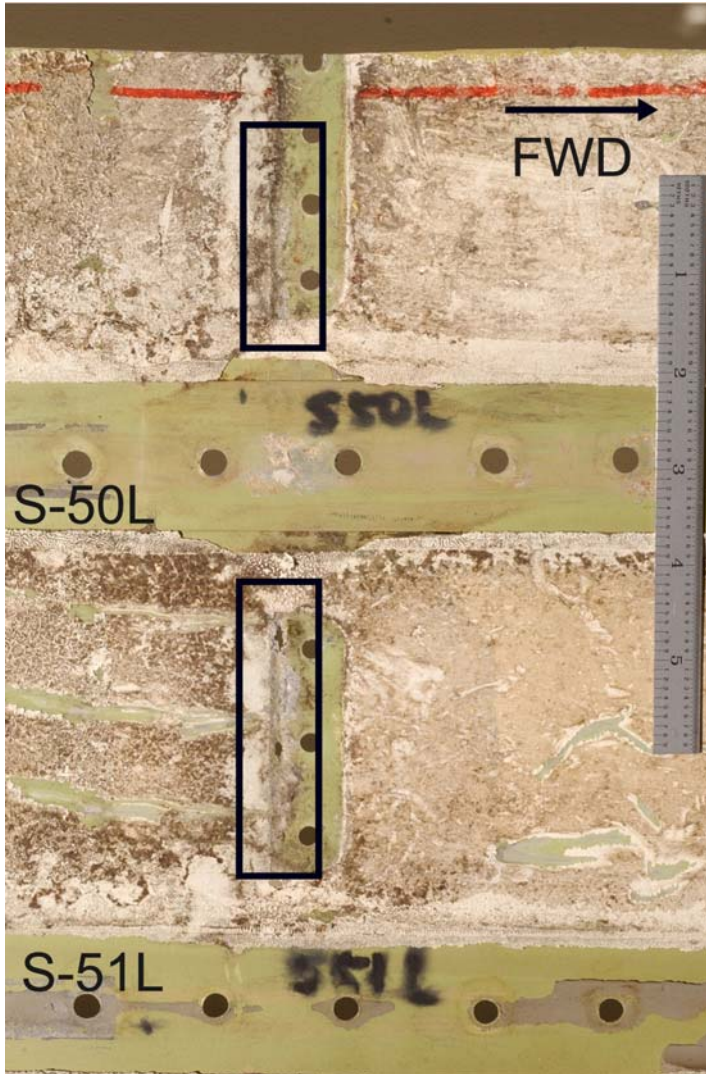
Corrosion was noted at several shear tie locations on the skin inboard surface sometimes penetrating completely through the skin thickness. General features of this damage and the general condition of the skin indicate that the corrosion most probably existed at the time of the accident, and was not a result of salt water immersion after the event. Photographs displaying these corrosion features are shown in Figures 47 through 49. Table VIII records visual observations of these features.

Figure 47. SKIN CORROSION FEATURES AT STA 2080 - Areas of corrosion are identified with rectangles above. Corrosion penetrated completely through the skin thickness at the shear tie located between S-50L and S-51L.

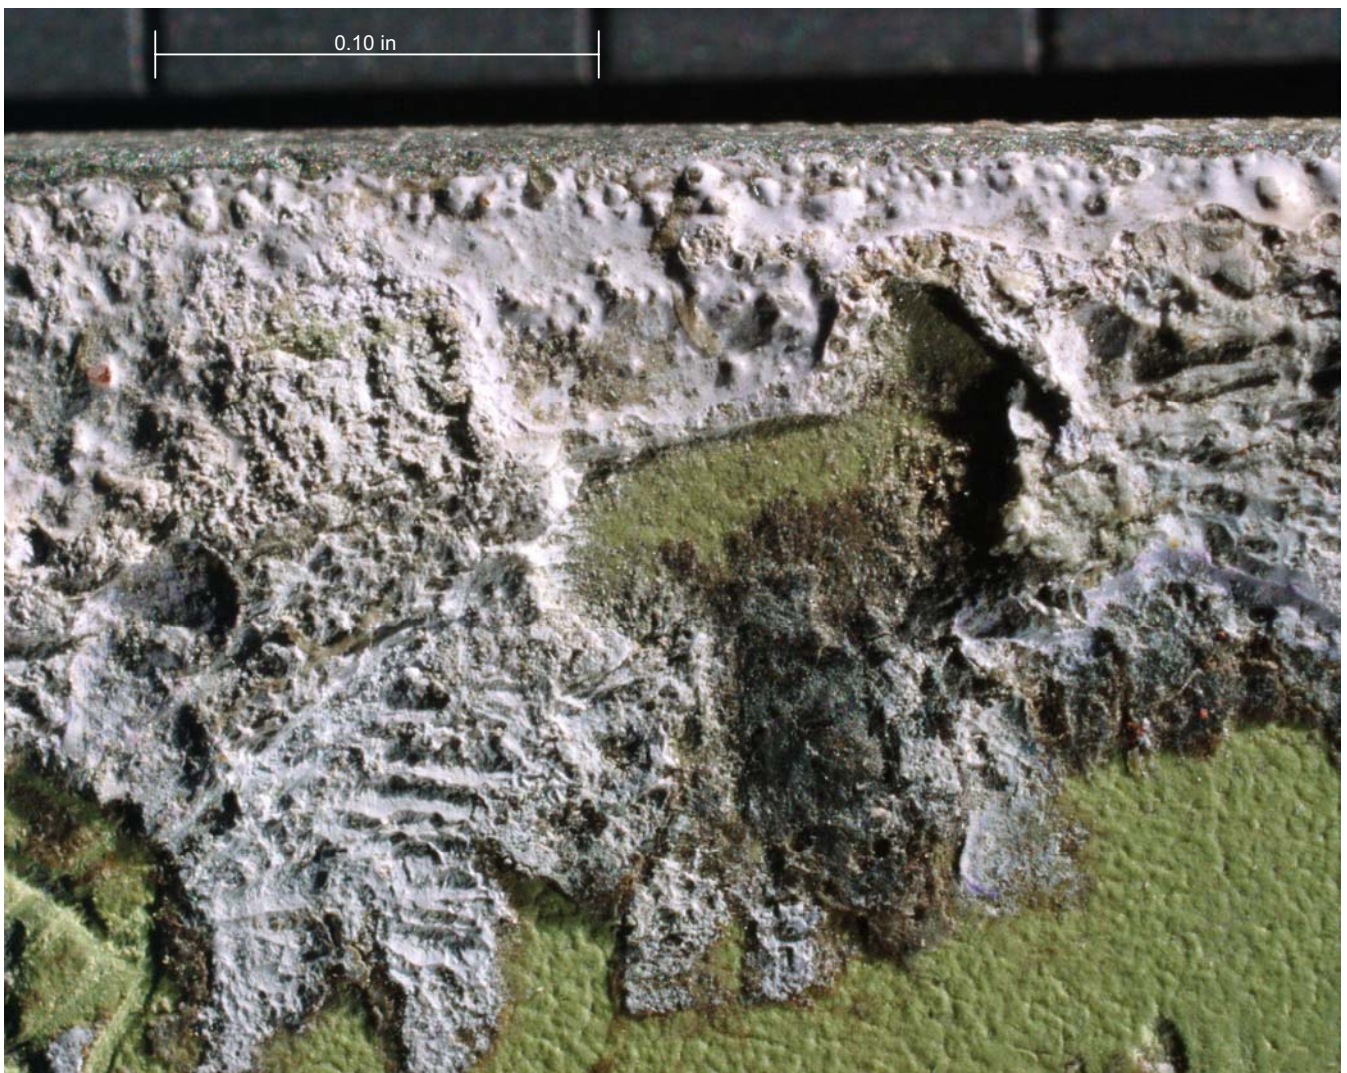
Figure 66.  
Higher magnification image of light colored deposit on faying surface of doubler in the vicinity of hole 15. Note the smooth bubbled appearance of the deposit adjacent to the edge of the doubler indicative of paint flow into the joint.

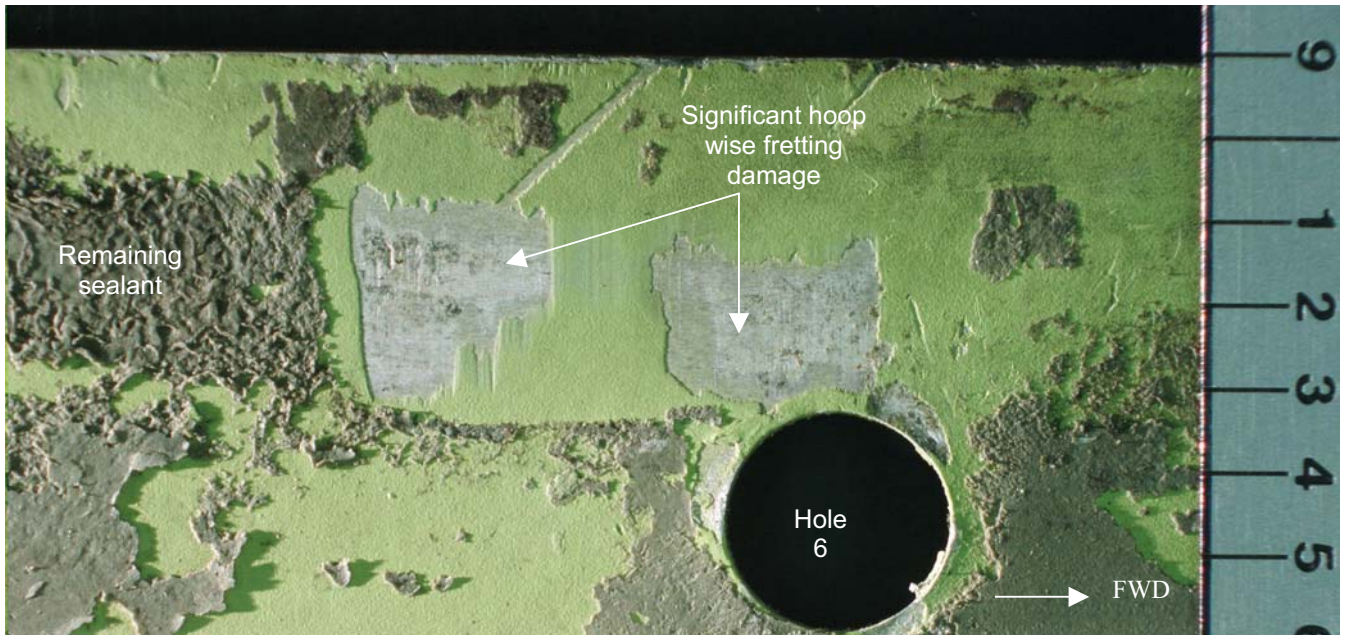
Figure 68.

Faying surface of doubler in the vicinity of hole 6 showing an example of significant fretting damage at the 10:00 to 11:00 and 1:00 to 2:00 clock positions.

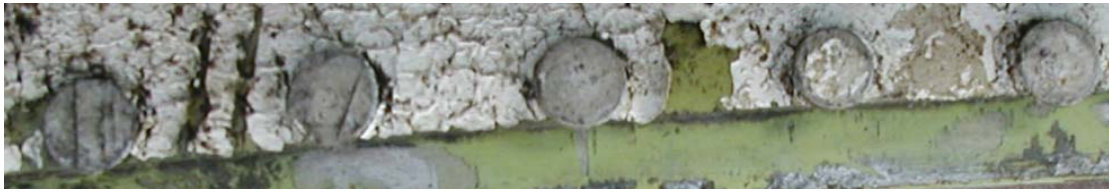
Multiple crack initiation sites along length
