**SMOKE CAME OUT OF THE DADO PANEL IN
REAR CABIN DURING PASSENGERS
DISEMBARKING**

**EVA AIRWAYS FLIGHT BR67
BOEING 747-400, B-16410
BANGKOK SUVARNABHUMI INTERNATIONAL
AIRPORT FEBRUARY 23, 2008**

Final Report

Report Number: ASC-AFR-09-05-002

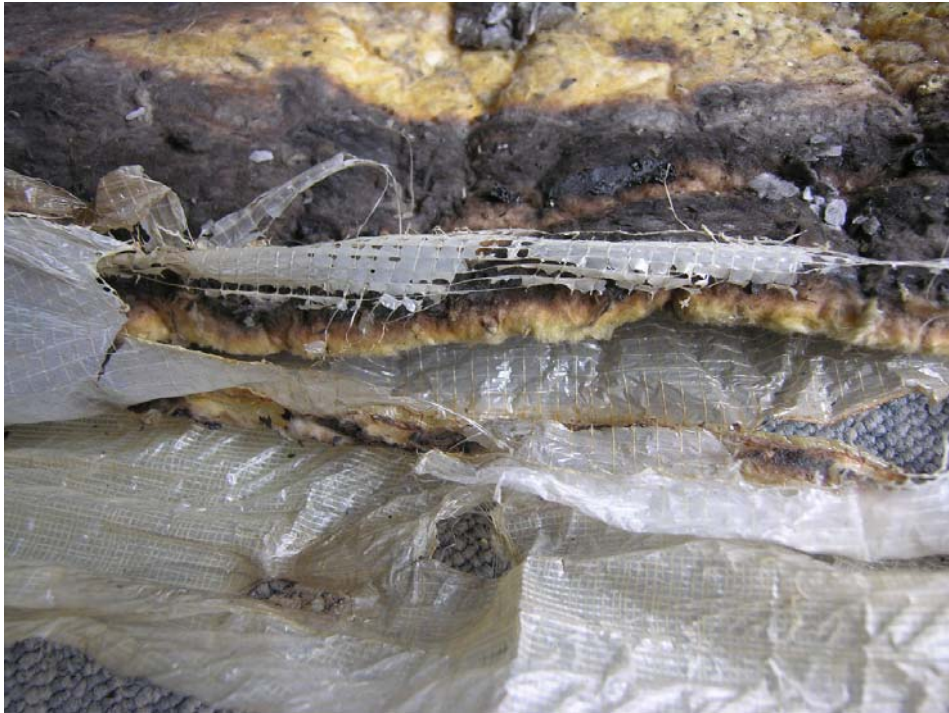
Fig. 1.12-9 Face Sheet of Insulation Blanket

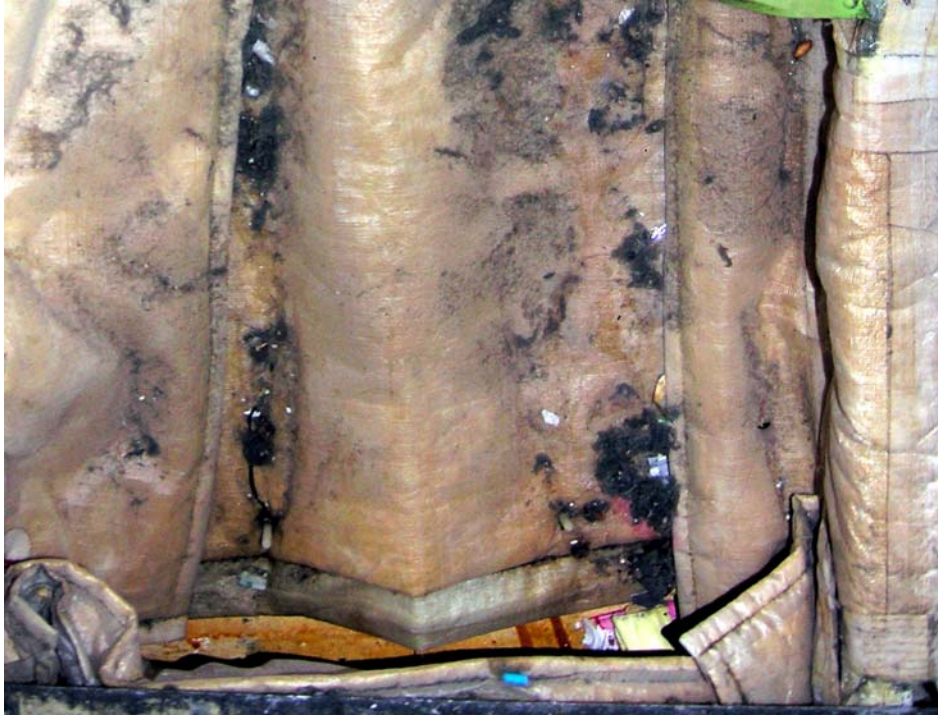
Fig.1.12-16 STA 1960~STA 1980 below the Cargo Compartment Floor

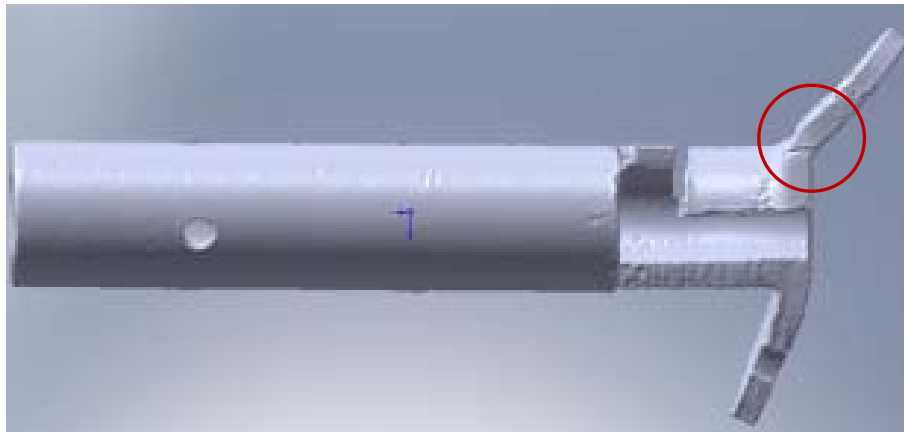
In order to modify the boundary condition of FEA simulation, a 3D optical scanning technology is conducted to scan and measure the failure standoff, and the geometric model of failure standoff is obtained⁹, shown in figure 2.1-3. As specified in Chapter 1.12.2.3, similar case was found on a sister ship register number B-16411 with identical APU power cable standoff installation at STA. 2060, where the standoff was found bent downward with a pulled loose blind rivet at the upper side and the lower blind rivet head clinched, refer to figure 1.12-35. As a result, investigation teams think the blind rivet at the upper side is loose slightly, and plastic deformation is happened in the upper standoff.

Fig. 2.1-3 a stereo lithography (STL) model of failure standoff
